MONITORING AND NUMERICAL ANALYSIS FOR TYPHOON MORAKOT INDUCED LANDSLIDE IN CAU-PIN AREA

Jeng Ching-Jiang¹ Tan Chih-Hao² Chung Ming-Chien² Lee Jiin-Fa³ Li-Yuan Fei³

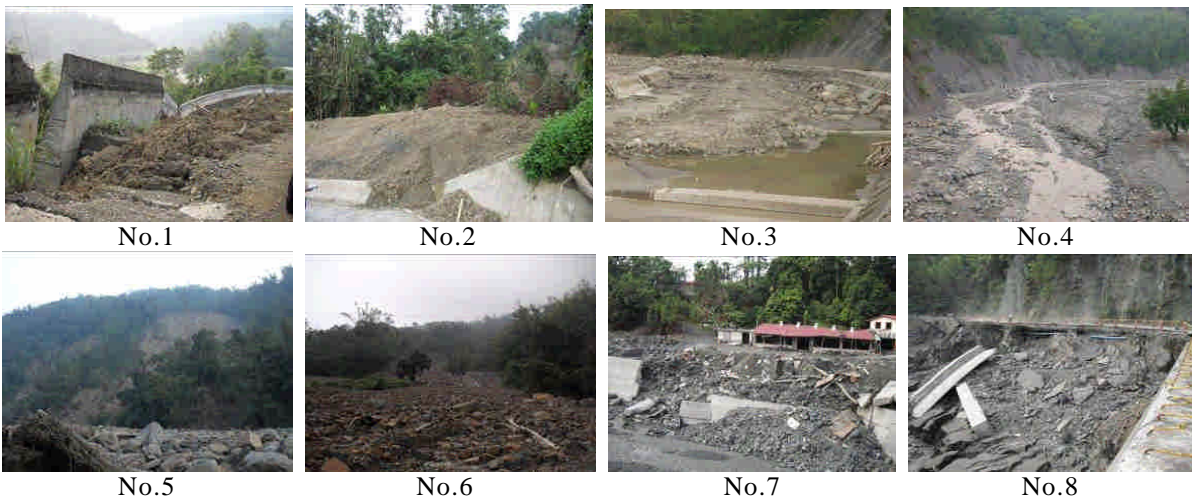
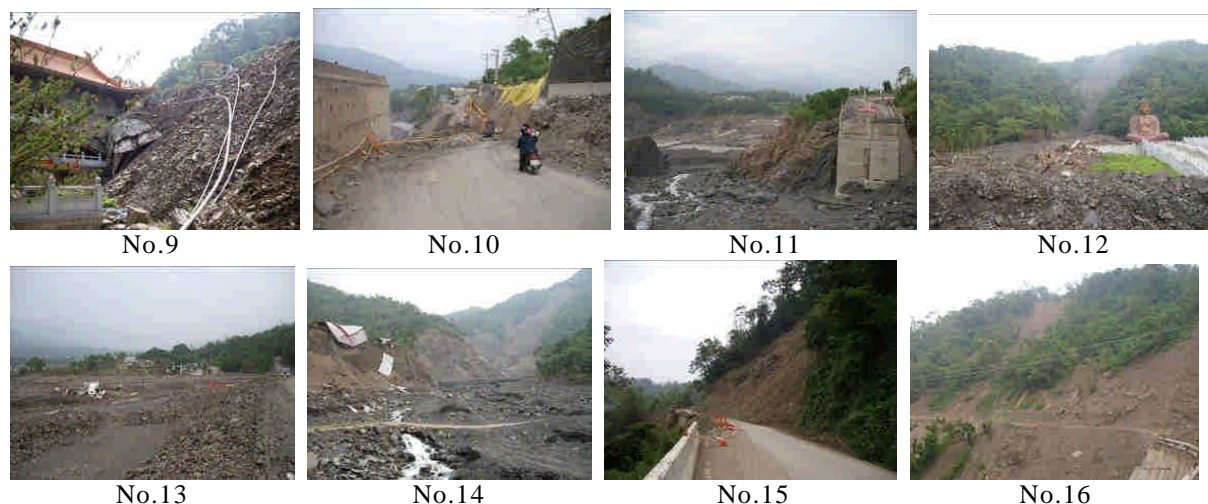
Fig.2 Landslide hazard investigation Photos in Kaohsiung and Pingtung area

Number	River and road location	Coordinate(E)	Coordinate(N)	Disaster type
1	Chishan River, Jia Xian county road No.130, Above Lung Feng Temple	209070	2553609	Road side retaining wall Damage
2	Chishan River, Jia Xian county road No.130, Under Lung Feng Temple	209143	2553535	Soil collapse and retaining wall lateral movement
3	Chishan River, Yu Kuang River, Tsz En Bridge	208611	2553769	River bank collapse and riverbed silt up
4	Chishan River, Yu Kuang River, No.3 Bridge	210035	2554425	River bank collapse and riverbed silt up
5	Chishan River, Yu Kuang River intersection with Peng Ping Keng	210735	2555086	Debris flow caused by landslides
6	Chishan River, Di Shuei Bridge, county road No.128	208047	2551122	Debris flow caused by landslides
7	Laonong River, Liou Guei Route 27, Bang Fu Chi Bridge	214856	2545023	Debris flow and river bank erosion
8	Laonong Rive, Route 27, Taiwan Power Company Water Inlet	215408	2545216	River road landslides

9	Laonong Rive, Route 27, Miao Chung Temple	215917	2545504	Behind temple landslides
10	Laonong Rive, Route 28, Shin Fa Road	215509	2547000	Debris flow and river road landslide
11	Laonong Rive, Route 29, Shin-Bau Bridge	216180	2549411	Debris flow triggered bridge broken
12	Laonong Rive, county road No.113, Tsai Hung Mountain Buddhist Garden	216336	2550459	Slope landslide and debris accumulation
13	Laonong Rive, Route 27; Shin Fa village:32	217202	2551044	Debris flow destroyed houses
14	Laonong Rive, Route 27; Bu-Lao River, Shin Kai Bridge	217574	2551478	Debris flow triggered landslide and destroyed house
15	Laonong Rive, Route 20	211456	2551644	Roads slope sliding
16	Laonong Rive, Route 20, Nei Liao Bridge	211235	2551329	Roads slope sliding and broken bridge

Table 1 provides a summary of the destruction within the observed area. The majority of damage to the area was the result of landslides near roads and riverbanks, and debris flows as indicated in No. 5 through No. 14. A preliminary evaluation relates the destruction to torrential rains which led to

infiltration, seepage, rise in groundwater levels and ultimately slope failure causing roads and buildings at the toe of the slope to be buried.

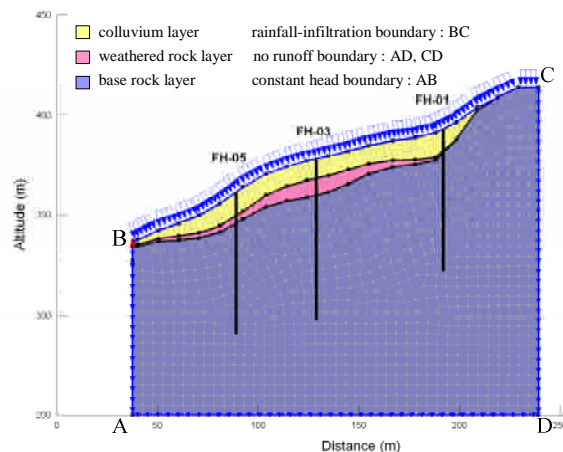
Fig.5 The hydrology geology concept model of Baolung investigation area

The boundary conditions of the hydrologic concept model are shown in Fig. 5. To analyze the infiltration and seepage flow, the left side boundary was set as a constant head boundary equal to the water level of the toe creek trench. The right side boundary was set as a constant because a crest line had already been established. The lower boundary was set as a no runoff boundary. The surface of the slope was then set as a rainfall- infiltration boundary. The steady state seepage flow refers to the average annual rainfall. The transient state seepage analysis was then set as the amount of precipitation. When the deformation analyzed was performed, the left and right sides were set at zero displacement in the horizontal direction, while in the bottom boundary both the horizontal and vertical displacements were zero.

The steady state seepage flow analysis aimed to align with the observed normal water level of well No. FH-01 and FH-05. Monitoring data prior to Typhoon Morakot, indicated the normal water level in FH-01 and FH-05 to be between GL-21~23 m and GL-14~15 m respectively. Through steady state seepage flow analysis it was determined that the water table at the top of the slope at well No. FH-01 is distributed under the base rock layer. While in well FH-01 to the toe of the slope the water is under the weathered rock layer. In addition, it is known from the seepage flow vector that the seepage velocity along the interface between the colluvium layer and the weathered rock layer is more rapid.

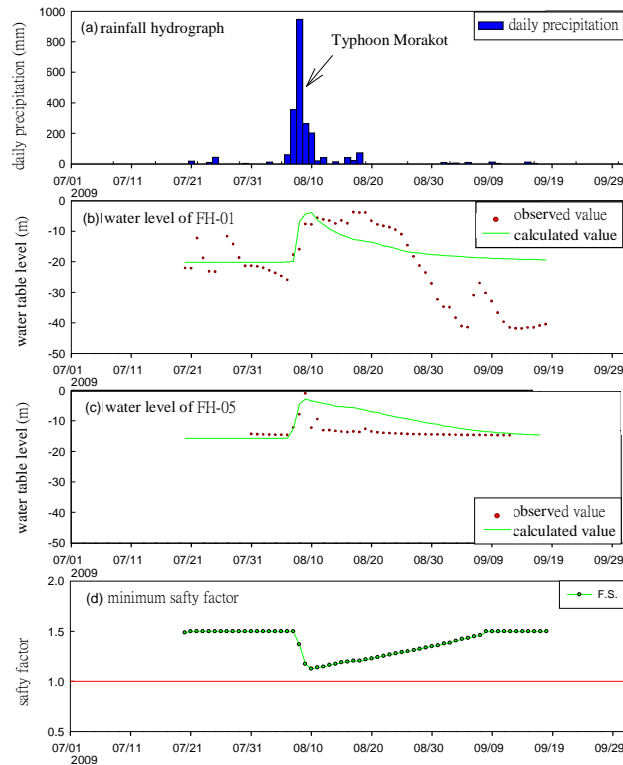
Fig.6 Two-dimensional slope stability analysis results of the Baolung investigation area vs. infiltration

The transient state seepage analysis was initiated from the above steady state analysis with normal water table levels, and set the slope surface as the rainfall infiltration boundary to lead to the situation of water level variation and water seepage flow in the rainfall conditions. The rainfall infiltration period used for the analysis was from July 20 to September 18, 2009. This period included Typhoon Morakot. The rainfall hydrograph is show in Fig. 6(a).

In Fig. 6(b) the dotted medium red line indicates the record for the water level of the observation well FH-01. The analytical results shown by the green solid line follow the water level variation trend for the period of Typhoon Morakot. However, the water level significantly descends to GL-42 m after the typhoon, and such water level dissipation eludes the analysis at this time. Figure 6(c) the medium red dotted line shows the water level at observation well FH-05 for the period of Typhoon Morakot. The concurrence of the analytical data (green solid line) shows that it can imitate the water level variation trend and the range of the water level for the period of Typhoon Morakot.

The safety factor variation for the period of Typhoon Morakot is shown in Fig. 6(d), and indicates that the typhoon caused the water table to rise because of rainfall, which decreased the safety factor. When rainfall ceased the water table level returned to normal and the risk of slope instability decreased.

During Typhoon Morakot, potential risk in the Baolung investigation area began to increase on August 8, and by August 10 the safety factor was at it's most threatening point of 1.125. This low safety factor was possibly the result of partial slope failure, small-scale failures in the area, or slip near

the toe of the slope. The slope failure occurred at the colluvium and weathered rock layers, as shown in Fig. 7(b). This result is consistent with the field investigation obtained after Typhoon Morakot. The field investigation found that the Baolung investigation area had a small-scale collapse at the slope toe. This event was also verified by data from section 3.3 in the content (c) of the surface and ground movement monitoring.

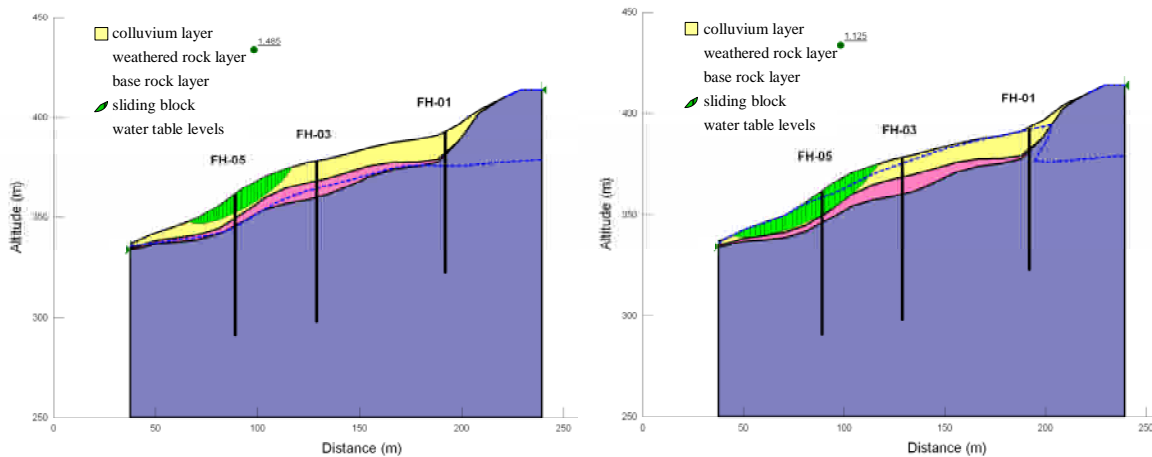
Fig.7 Result of safety factor of Baolung investigation area before the Typhoon Morakot.

All the hydrogeologic parameters were determined from the laboratory tests. For this study an auto-search method was adapted for the Baolung investigation area, and the limit equilibrium (Morgenstern-Price) method was used to assess risk in the area. Figure 7(a) is the result of the risk assessment for the Baolung investigation area before Typhoon Morakot. It shows that the section of land with the greatest potential for failure was located on the down slope and passed through the boundary of the colluvium and weathered rock layers. The safety factor of 1.485 indicates that the Baolung investigation area should be considered stable under normal circumstances.

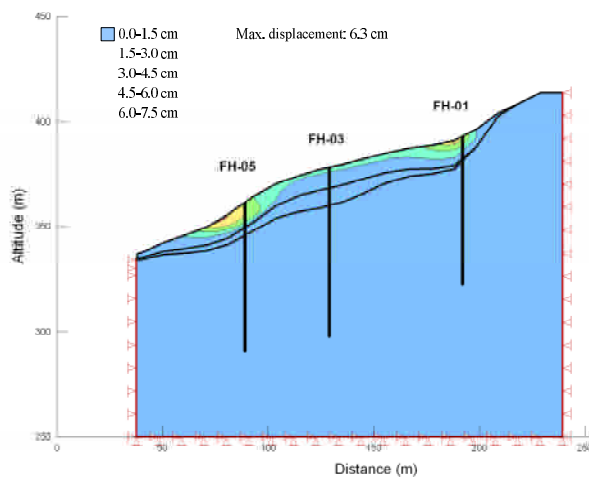
Fig.8 The deformation of the assessment results in Baolung investigation area

Figure 8 shows the results of displacement at the Baolung investigation area during Typhoon Morakot. The position with the most sliding potential was at the lower slope (hole FH-05) to the slope toe. The sliding block was consistent with the stability analysis (Fig. 7(b)). General speaking, the Baolung investigation area had no notable displacement during Typhoon Morakot. The greatest displacement found was approximately 6.3 cm.

This study examined the displacement analysis result through the inclinometers and observing deformation in the Baolung investigation area. Although this area showed slight displacement during Typhoon Morakot, the observed displacement at holes No. FH-01, FH-03 and FH-05 indicate it was not significant (lie among the 3~8 mm). The strain indicated in the numerical analysis, shows the ground surface displacement on each hole ranged between 8~32 mm. The best trend occurred at No. FH-03. At holes No. FH-01 and FH-05, the simulation results were greater than the monitoring data, showing the analysis results to be conservative.
