Case Study of Ji-Lou Landslide Triggered by Typhoon Morakot

Ming-Chien Chung¹, Chih-Hao Tan¹, Gin-Shan Wang¹, Li-Yuan Fei²

¹Geotechnical Engineering Research Center, Sinotech Engineering Consultants, Inc., Taipei, TAIWAN, China

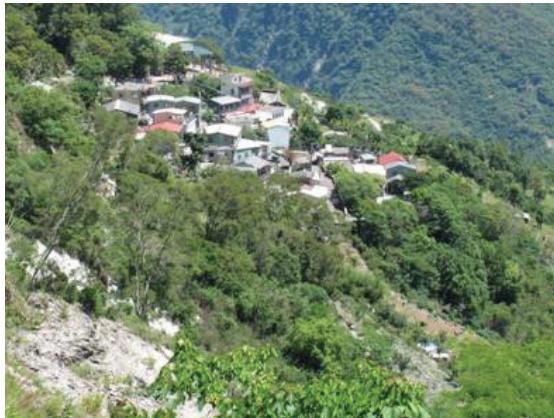
(a) Before the Typhoon Morakot disaster

Ji-Lou tribe, located at Gaoping river watershed in the southern Taiwan, is an active landslide due to typhoon events. Coordinates for the case study site are 224221, 2515673 (TWD97). The site was selected as the results of previous reports and geological survey. Fig. 1(a) shows the panorama view of Ji-Lou tribe before Typhoon Morakot. On August 8, 2009, Typhoon Morakot brought significant rainfall causing landslide at the down slope of the Ji-Lou tribe which shown as Fig. 1(b).

Fig. 1 Panorama view of Ji-Lou study area and landslide photo triggered by Typhoon Morakot.
