MONITORING AND NUMERICAL ANALYSIS FOR TYPHOON MORAKOT INDUCED LANDSLIDE IN CAU-PIN AREA

Jeng Ching-Jiang¹ Tan Chih-Hao² Chung Ming-Chien² Lee Jiin-Fa³ Li-Yuan Fei³

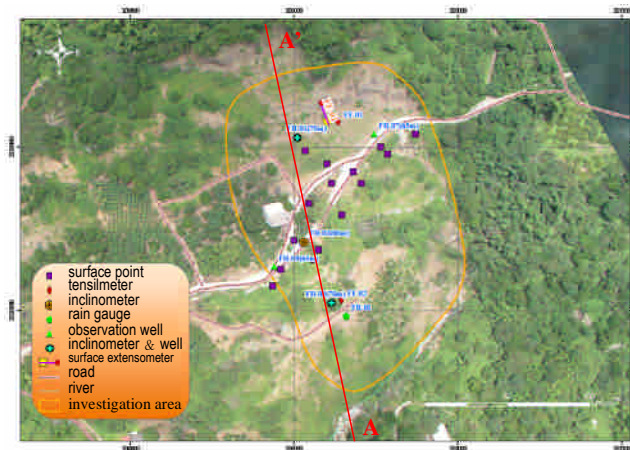
Fig.4 The monitoring system set up in Baolung investigation area

The locations of surface observation points are shown in Fig. 4. Measurements were taken before and after Typhoon Morakot. Observations found that after Typhoon Morakot the displacement of each point was not significant, with only a slight displacement ranging between 0.22~1.34 cm. This shows that the Baolung site has only partial creep, and evidence of a large-scale deep slide is lacking.

The surface extensometers shown in Fig. 4, were arranged according to an anticipated event such as Typhoon Morakot. Surface displacement at the top of the slope was found to be about 2.2 cm. Ground movement measurements were also taken prior to the typhoon event. Monitoring results surrounding Typhoon Morakot indicate that the Baolung investigation area has not experienced a

The monitoring plan of the matrix suction of the unsaturated shallow soil is shown in figure 4. The monitoring results indicate: (1) matrix suction decreases with rainfall; (2) matrix suction slowly increases after rainfall has ceased; (3) matrix suction descends with the exaltation of water content, and is reacted from the deepest (3.0 m) first, then moves to the shallow layer (2.0 m and 1.0 m). This trend is contrary to typical rain seepage and occurs most likely because of the permeability of the surface soil and the small geographical area at the site that causes a slower speed of rain seepage. While the water table approach to the ground surface and lift to raise notable with the rain.
